SUNBATT Battery Service Manual

Sunbatt Peak 4.8/ 7.2/ 9.6/ 12.0

Sunbatt Flex 9.6/ 12.8/ 16/ 19.2/ 22.4/ 25.6

Version 1.0

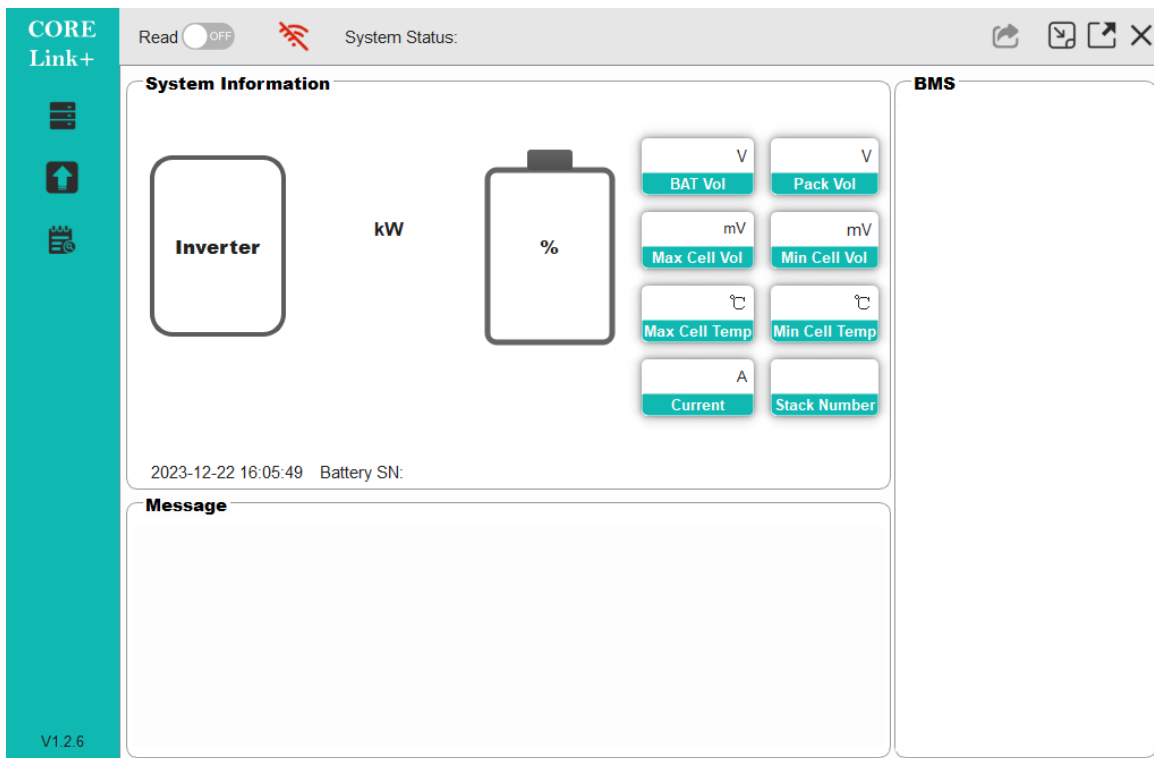
4.1. CORE Link+

With the CORE Link+ you can:

- 1) read the battery information;
- 2) update firmware;
- 3) export / download battery logs.

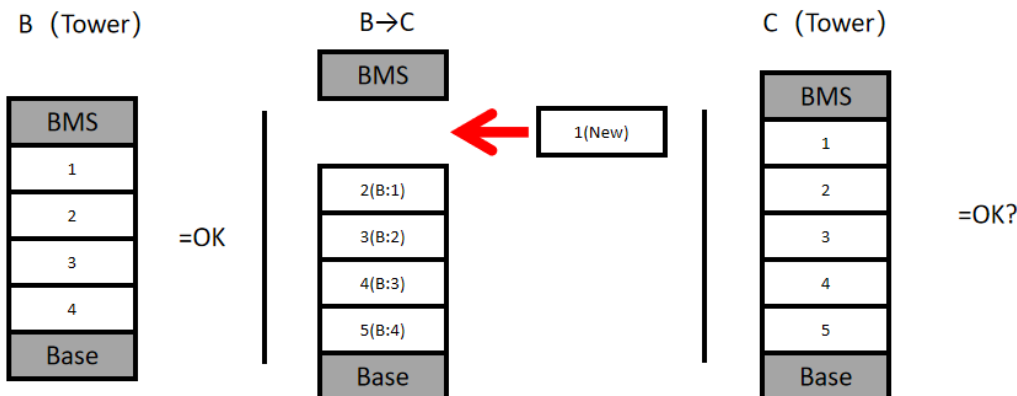
Make sure the minimum number of the battery stacks in a battery tower is available. (2 for Sunbatt Peak 1.0, and 3 for Sunbatt Flex 1.0)

- 1) **Check the system. If Okay**, add one stack at a time and check again.

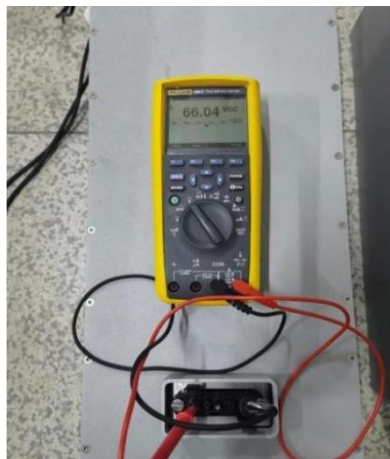
Remove the BMS and measure the tower voltage on the top stack as shown below.

Note: The nominal voltage per stack is 86.4~116.8 V for Sunbatt Peak 1.0, and 54~73 V for Sunbatt Flex 1.0.
